CAPITAL FACILITIES ASSESSMENT JULY, 2020

# DEERFIELD COMMUNITY SCHOOL DISTRICT

This evaluation is intended to survey the physical condition of the buildings located within the Deerfield Community School District and to develop a Capital Facilities Assessment. These buildings include Deerfield Elementary, District Offices and Deerfield Middle School / High School. This report analyzes the appearance and condition of the Architectural, Plumbing, HVAC, and Electrical systems of the buildings. This data is used to determine the feasibility and cost of implementing maintenance solutions to preserve the integrity of the buildings.

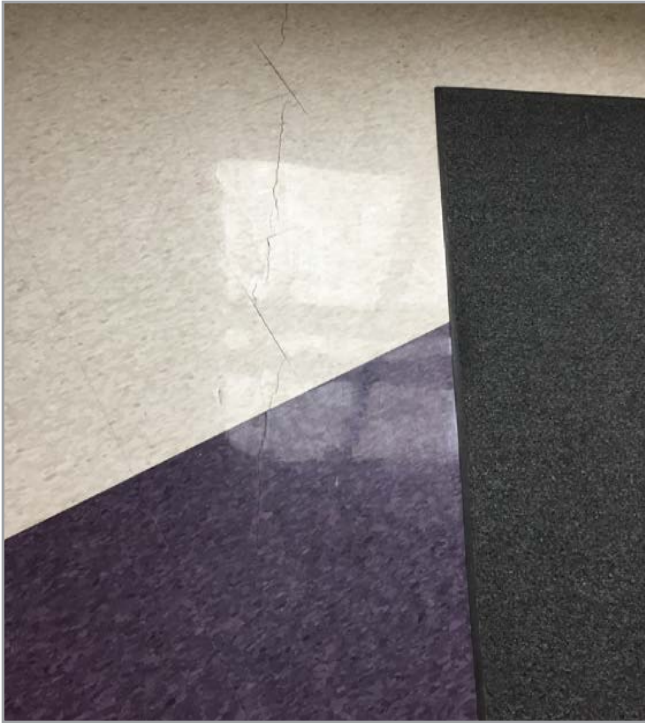
Damaged tile in Entry

- 1.1.1 Review Reading Room furniture layout to move books away from the windows or provide solar shades on the windows.
- 1.1.2 Replacing the vinyl composite tile in the Main Entry Corridor, the Cafeteria, and the Corridor by the gym.
- 1.1.3 Replacing the floor in the Kitchen.
- 1.1.4 Provide premolded corners on the vinyl base and replace gym floor base.
- 1.1.5 Replace discolored stair treads and risers.
- 1.1.6 Replace toilet partitions with floor mounted top braced partitions.
- 1.1.7 Replace pipe covers on toilet room lavatories.
- 1.1.8 Provide a floor control joint at the transition of slab on grade and lower level.
- 1.1.9 Replace or repair any window that has reported leaks.
- 1.1.10 Repaint metal handrails.
- 1.1.11 Repair masonry walls that have cracks.
- 1.1.12 Expand south side parking lot.

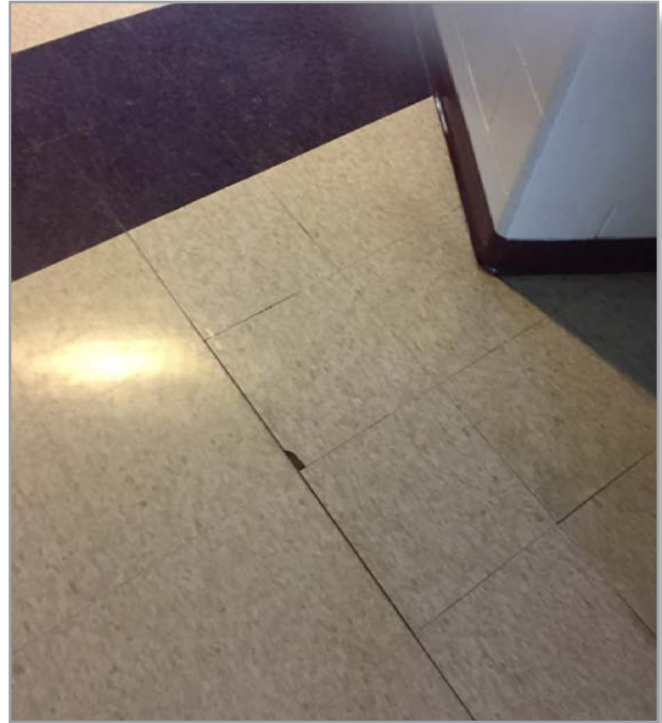
Damaged floor tile in Corridor

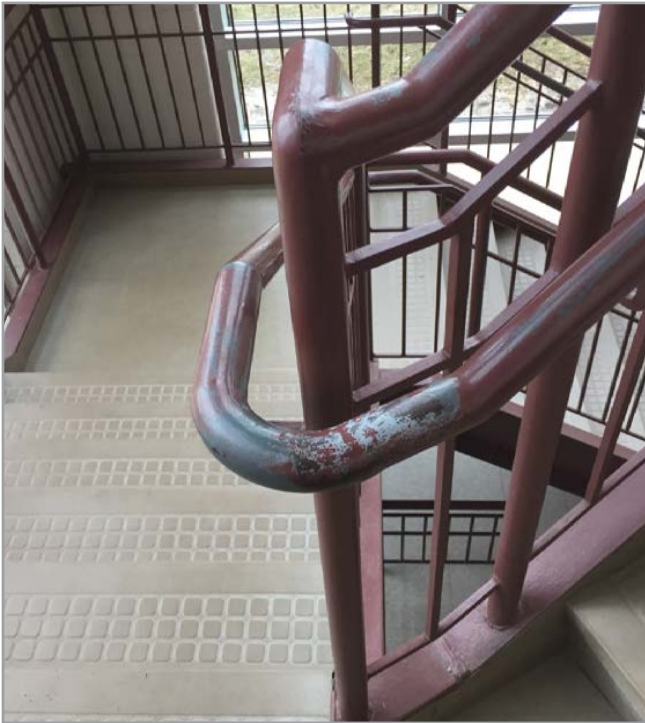
Stairway railings needing repainting

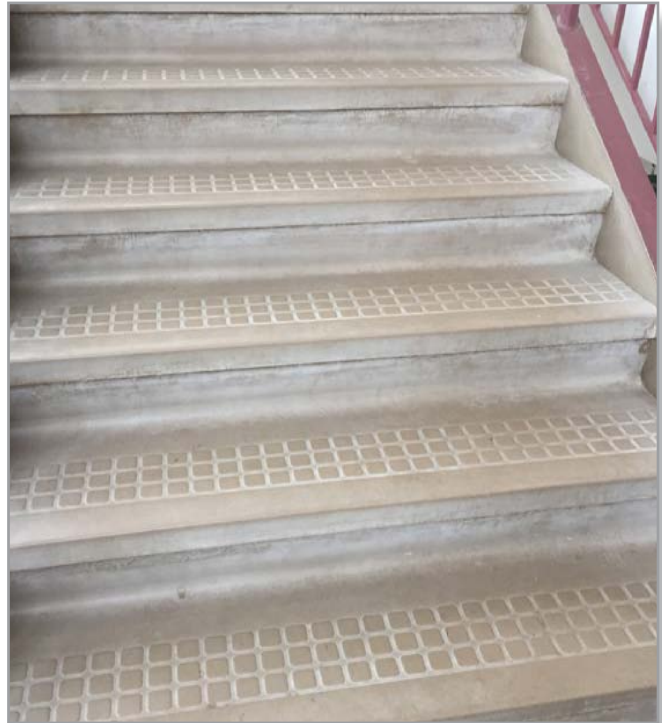
2.5.2.1 Treads and risers on the stair by the IMC have discolored and should be replaced.

Faded stairway treads and risers needing replacing

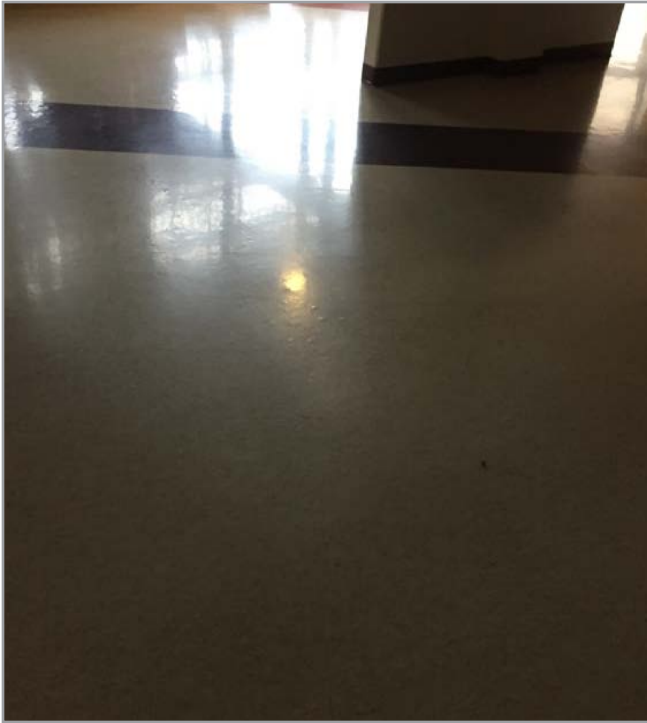
2.4.4.1 Observed areas appear to be in good condition with some areas of wear. Floors in the kitchen and Cafeteria along with hallways by the main entrance and gym are scheduled to be replaced.

Cafeteria floor that needs to be replaced

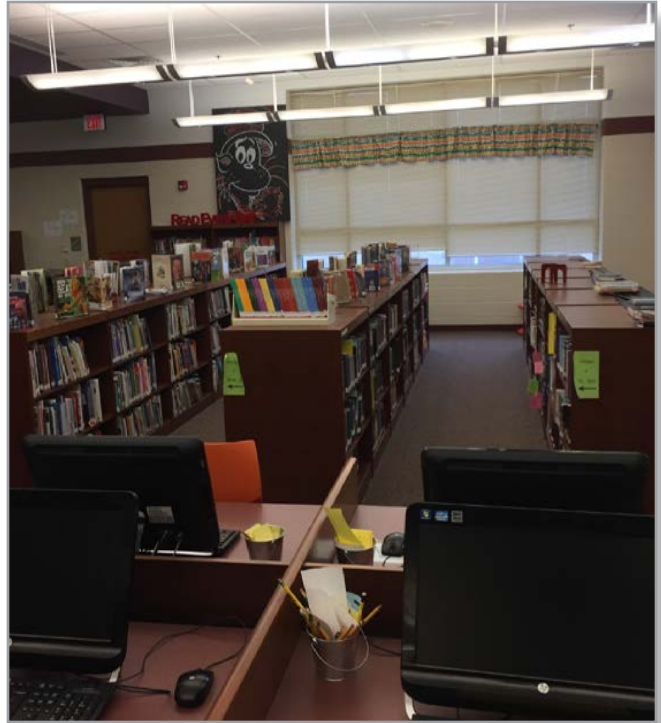
2.3.2.2 IMC windows require solar shades in order to eliminate UV damage of the books or the furniture should be rearranged to move the books away from the windows.

Provide solar shades for IMC windows

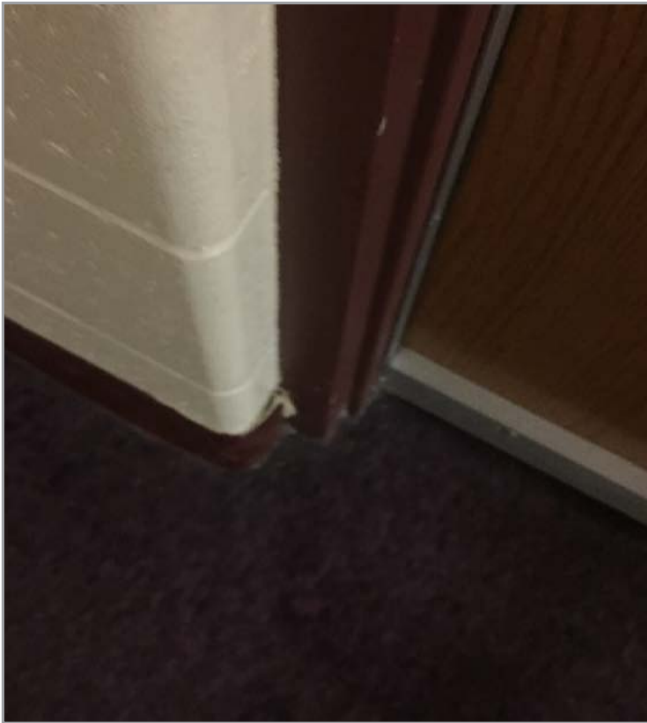
2.4.4.2 The vinyl base return at the doors are loose and curling. Recommend to replace the base with preformed corners.

Provide premolded corner floor base

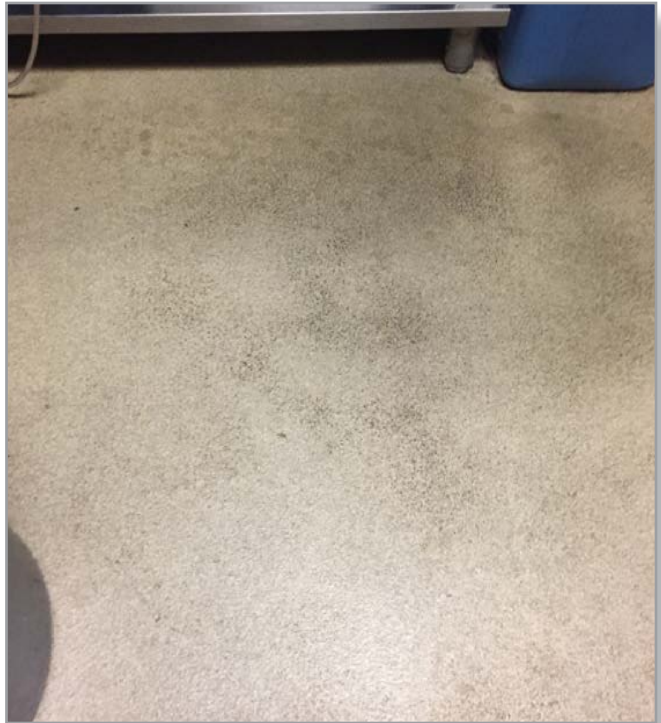
Soiled kitchen floor in need of replacing

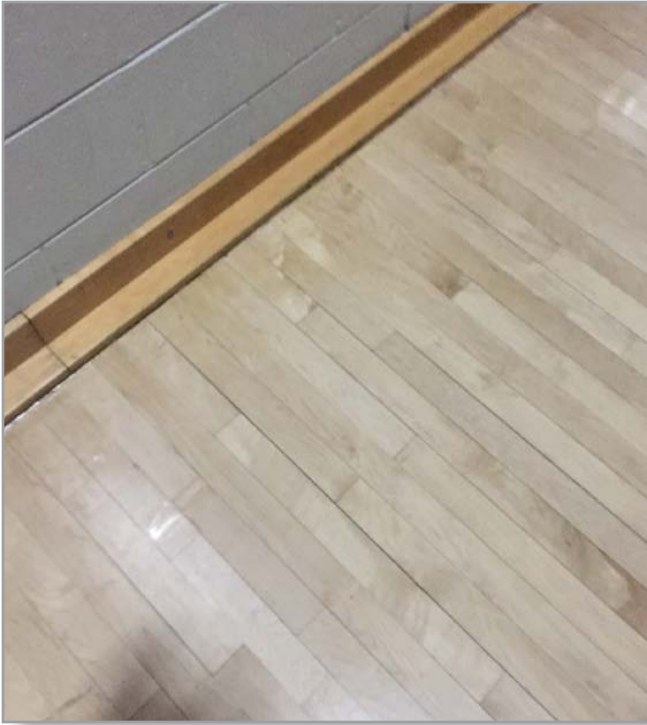
2.4.4.3 The base in the gym is loose. Recommend to replace the base with a vinyl vent cove base.

Loose gym floor base in need of replacing

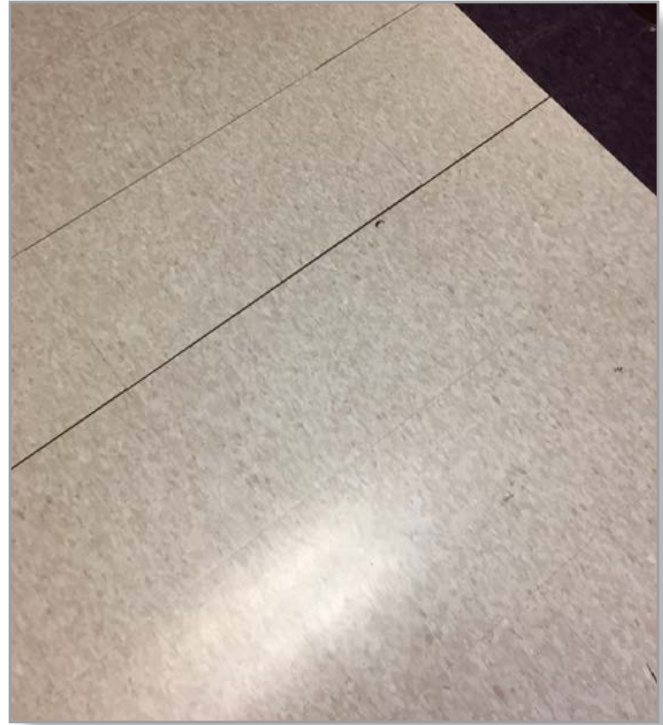
Provide a control joint in tile floor (soft joint)

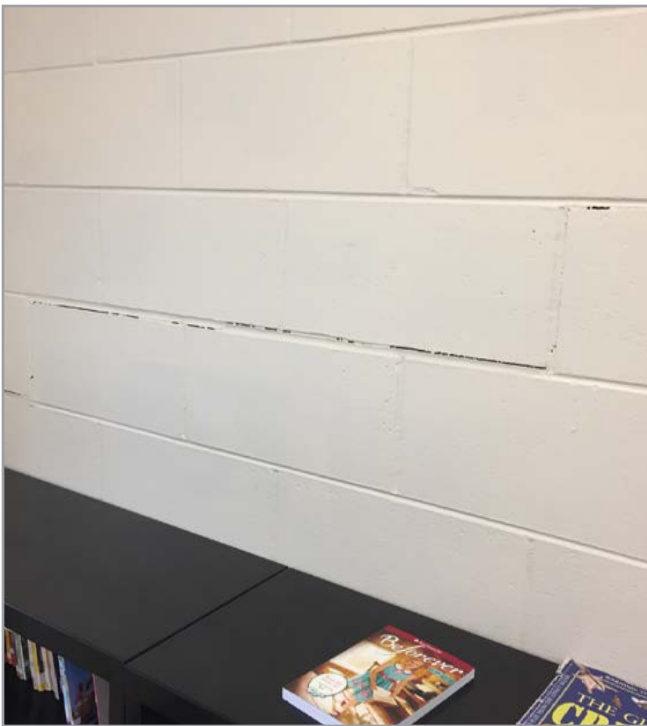
2.4.6.2 Observed minimal cracking at masonry walls. Repair approximately 100sf of masonry partitions.

Repair mortar joints in masonry wall

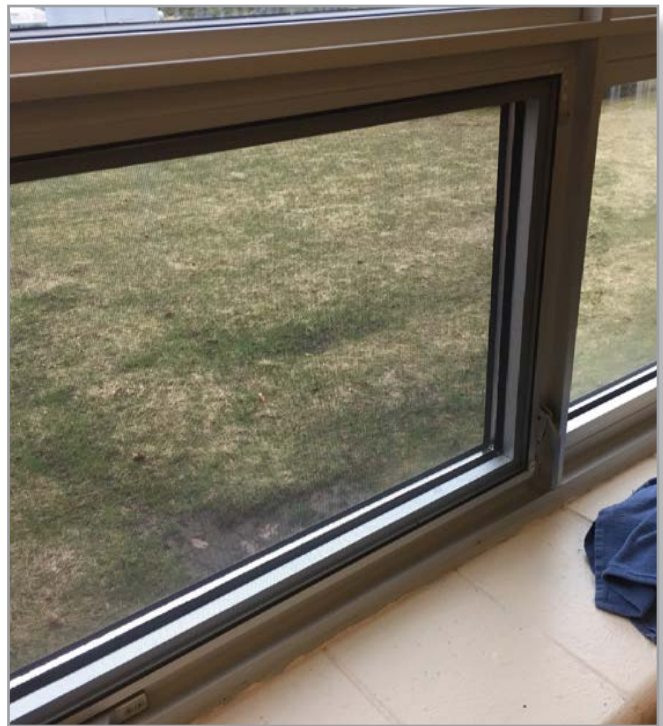
2.3.2.1 Some of the windows were reported to leak. It was observed that some of the windows had towels on the sills to catch the water. Any window that are reported to leak should be replaced. Budget based on estimated quantity of 5 windows.

Replace leaking window

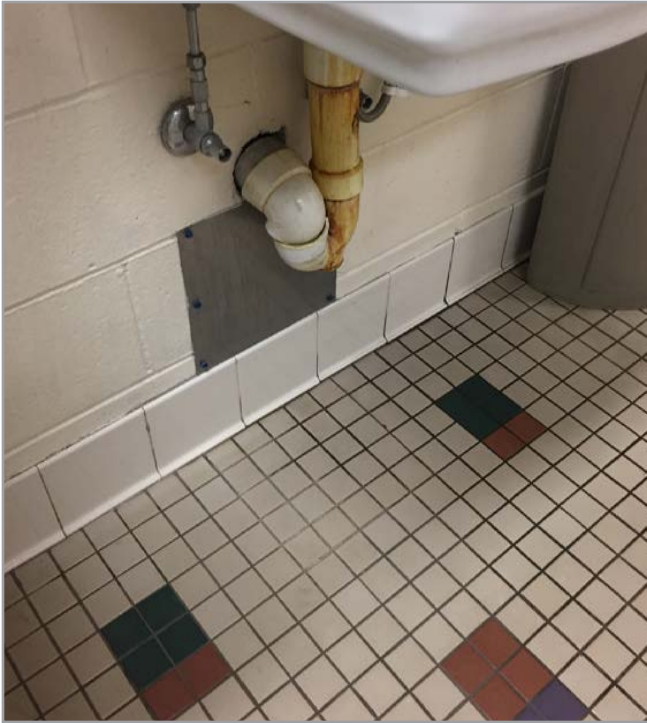
2.4.2.3 Pipe covers on toilet room lavatories need to be replaced.

Replace pipe covers in the Toilet Rooms

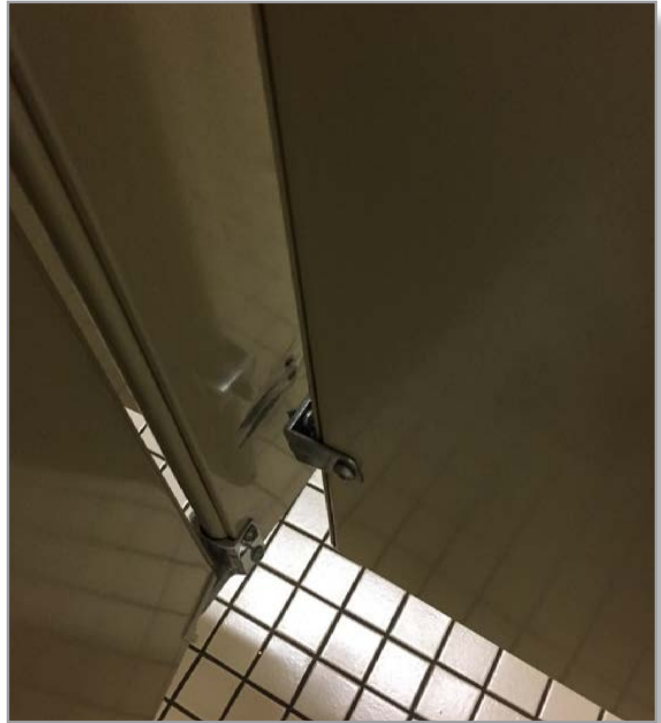
2.4.2.2 The ceiling hung toilet partitions are loose with damage connectors at the panels. It is recommended to replace the partitions with floor mounted top braced partitions.

Replace damaged toilet partitions

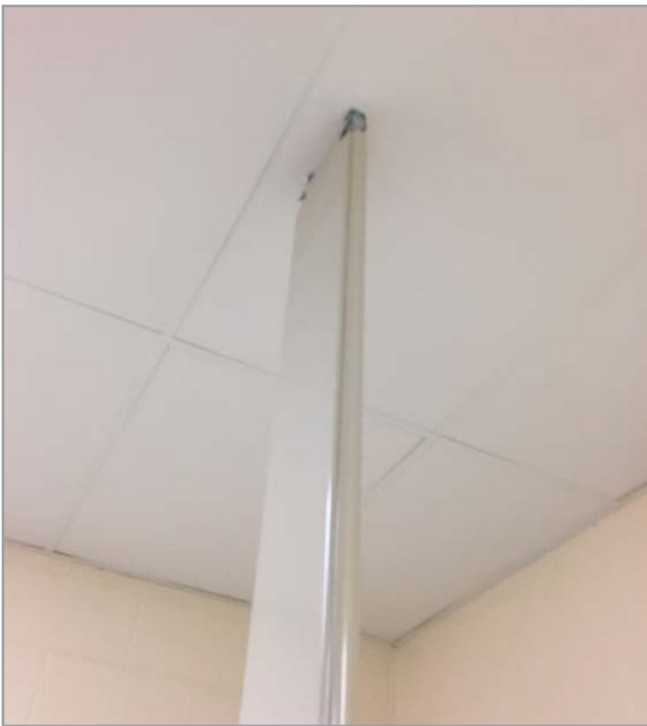
Replace toilet partitions with floor mounted overhead braced partitions

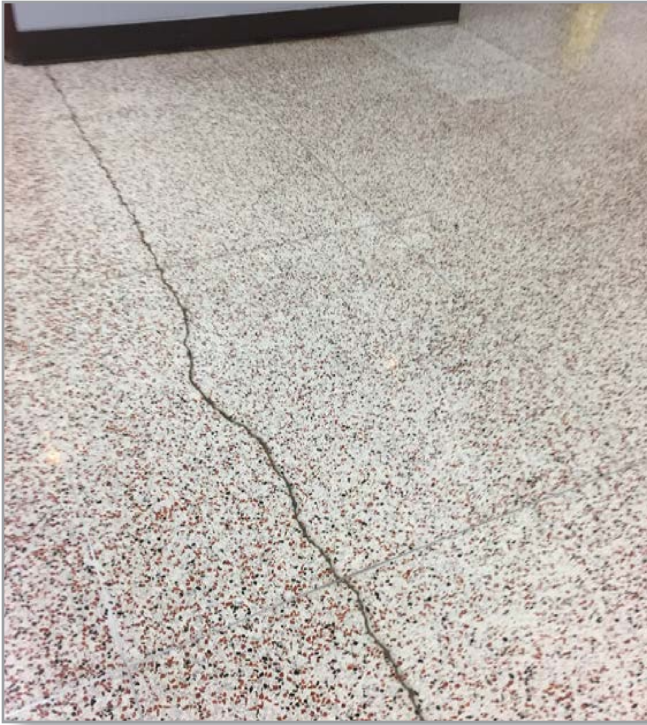
7.4.5.2 The cafeteria terrazzo floor has several large cracks and should be replaced. The terrazzo flooring in the entrances is spalling and is in poor condition. The budget includes repairs at these locations. It should be noted that there is potential the repairs are not an exact color match to the existing terrazzo product.

Terrazzo floor cracked in Lobby D101

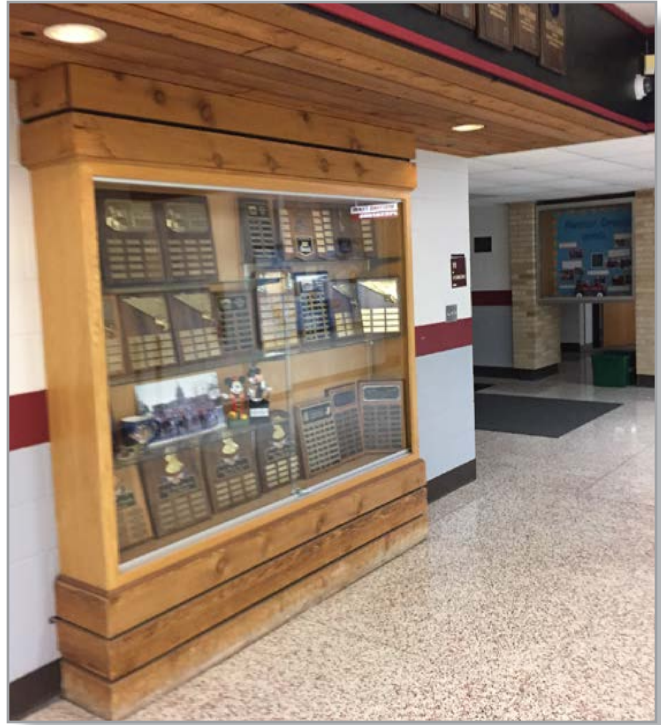
Display chase needs updating in Commons D100

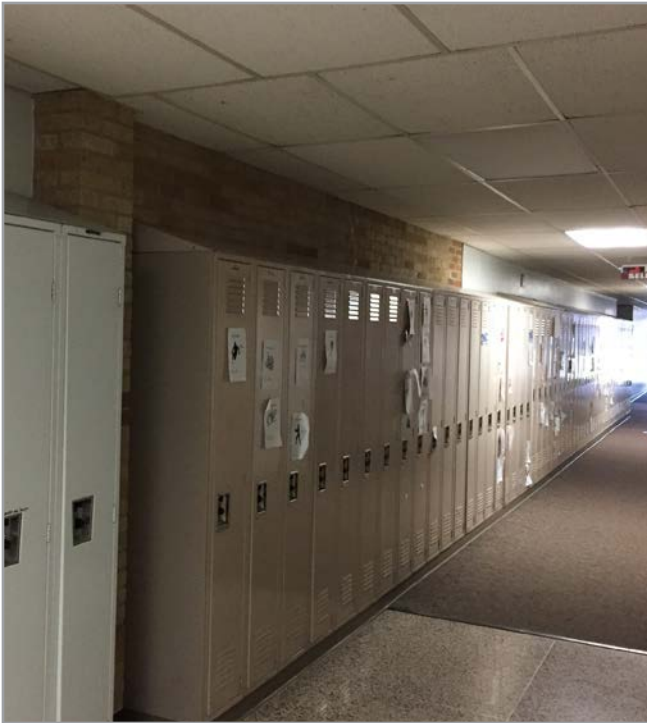
7.4.8.3 Existing metal lockers in the corridors are past their useful life and should be replaced. Budget includes replacement of approximately 250 existing lockers.

Corridor lockers in need of replacing in Corridor A149

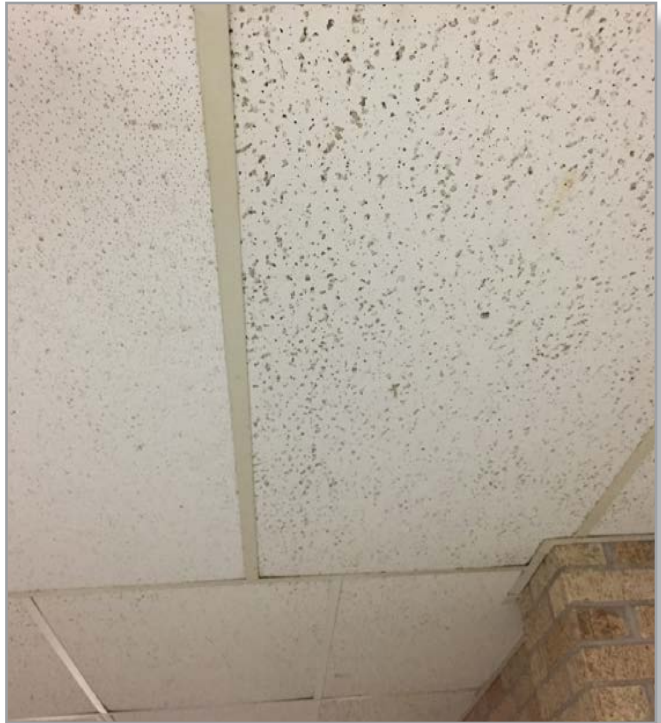
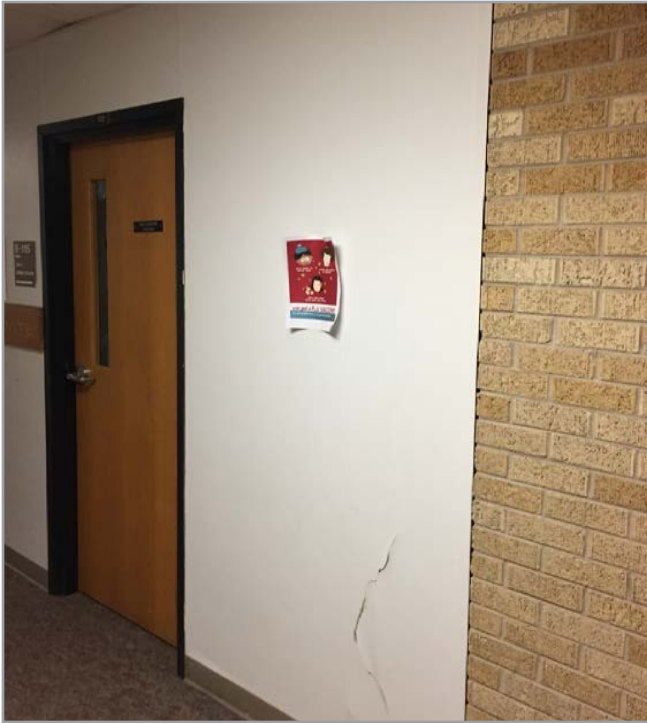
Different ceiling tile in Corridor A109

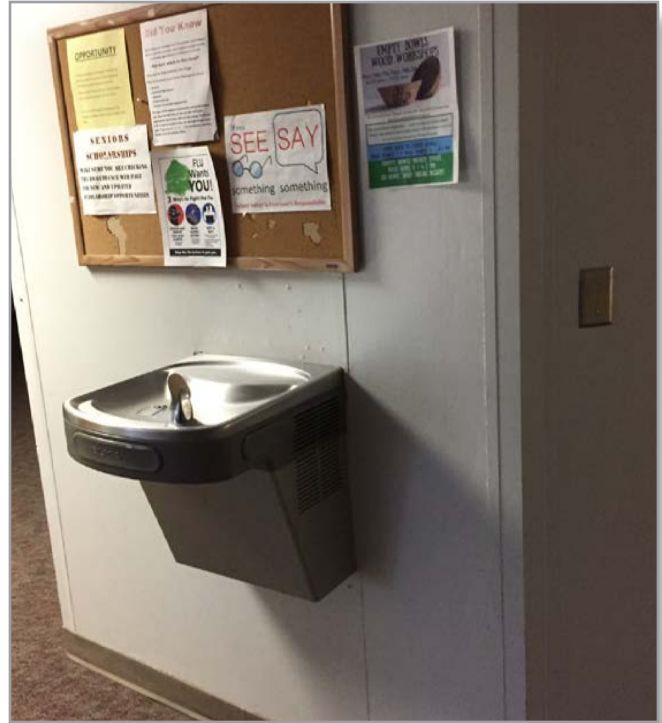
Provide high low drinking fountain in Corridor A109

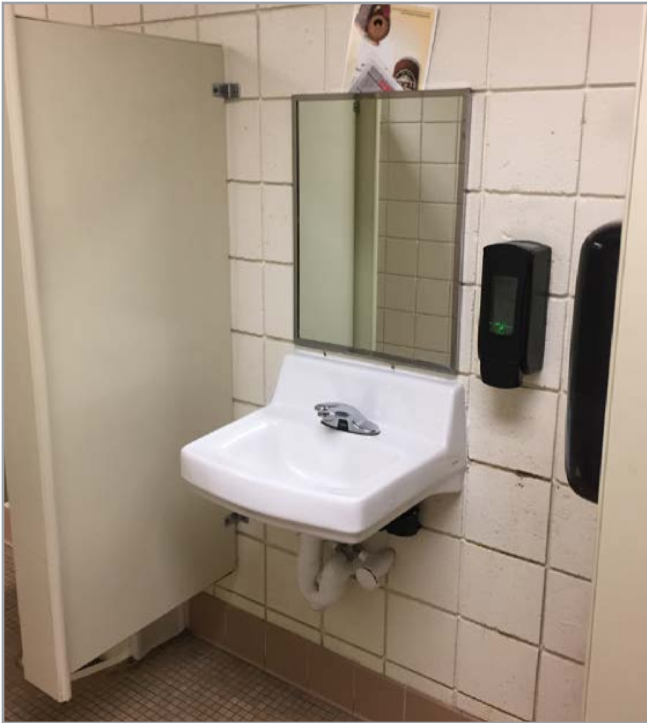
Upgrade finishes and accessibility in Toilet Rm A116

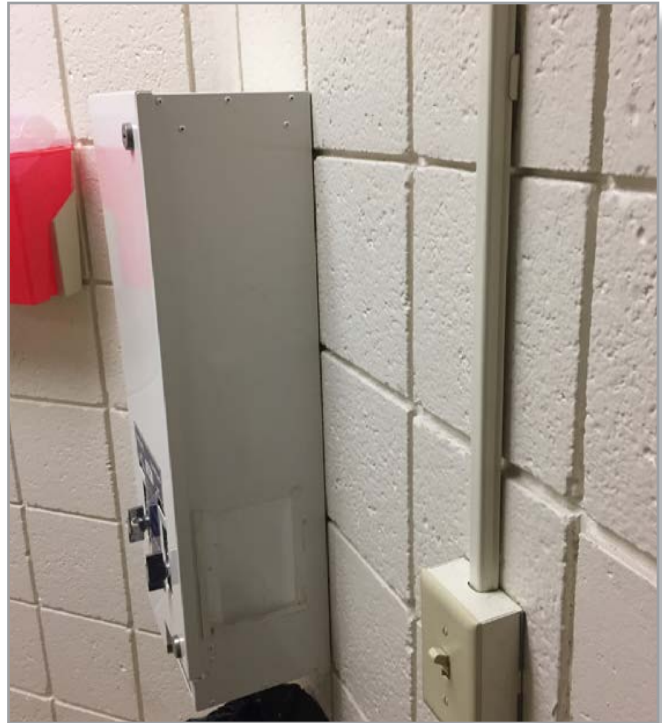
Upgrade finishes and accessibility in Toilet Rm A120

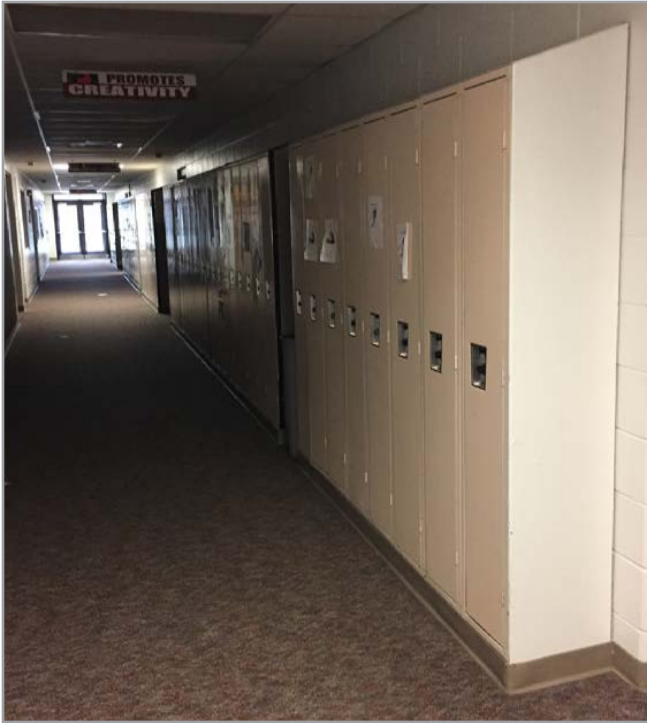
Upgrade floor finish to epoxy in Corridors

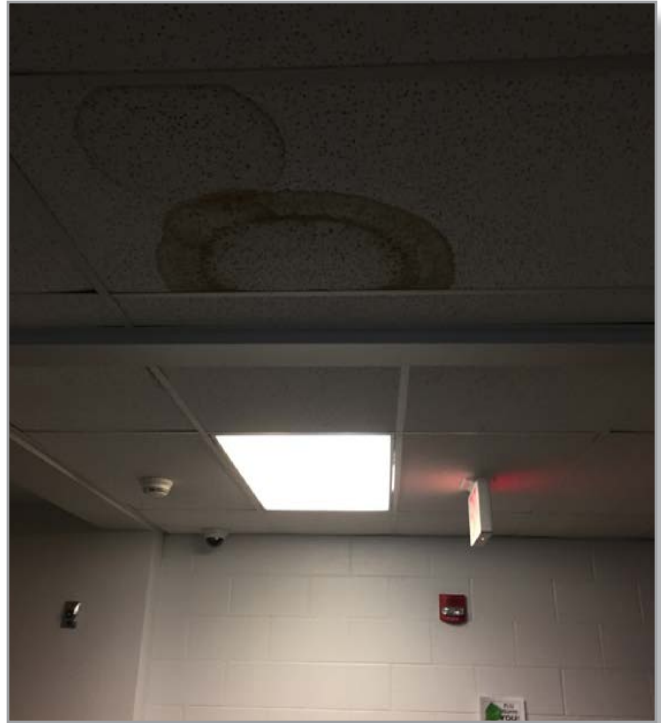
7.4.6.1 Most of the ceiling tiles and grids are in poor condition and should be replaced. Ceiling grids are discolored and the tiles are either cupping, sagging, or both. Budget includes replacement of approximately 33,000 square feet of standard ceiling tile and 7,275 square feet of vinyl coated ceiling tile. This budget does not include relocation of any low voltage wiring that is currently supported by the existing ceiling grid. That wiring would need to be anchored to the existing structure.

Water damaged ceiling tile in Corridor

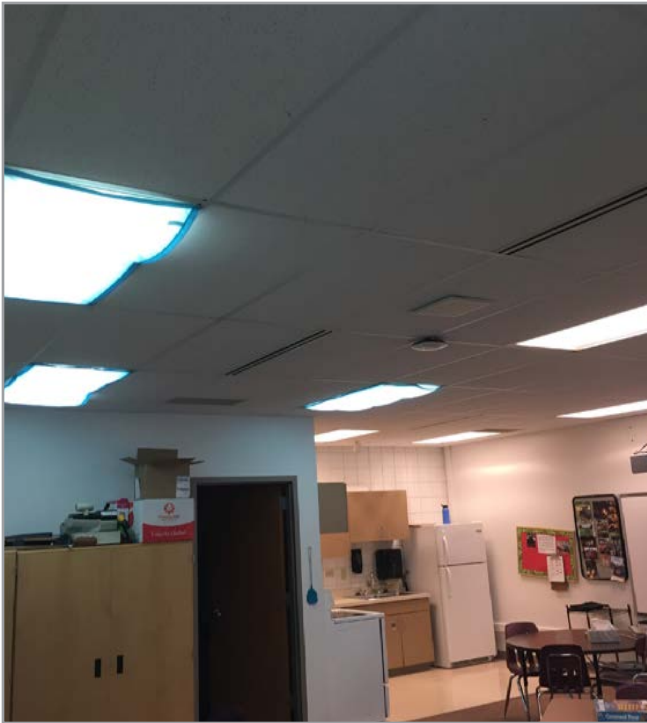
Provide new light fixtures in Special Ed A104

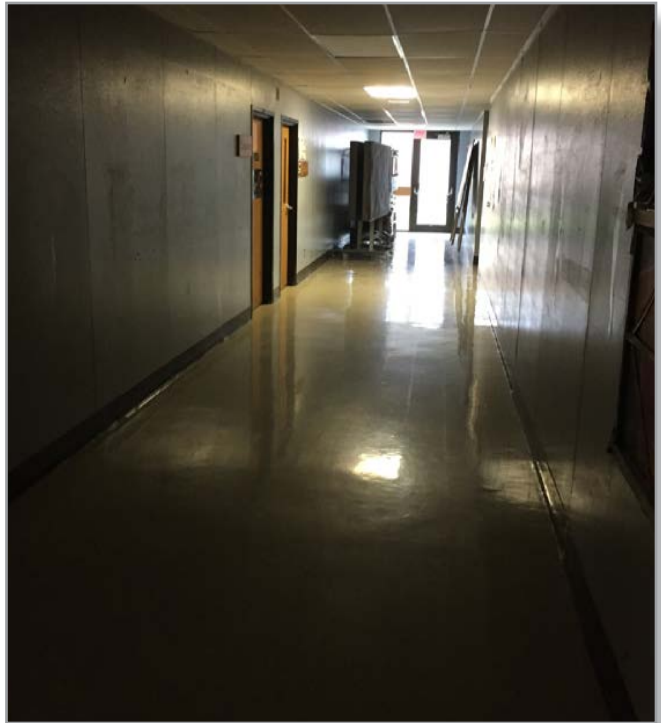
Upgrade finishes in corridor A136

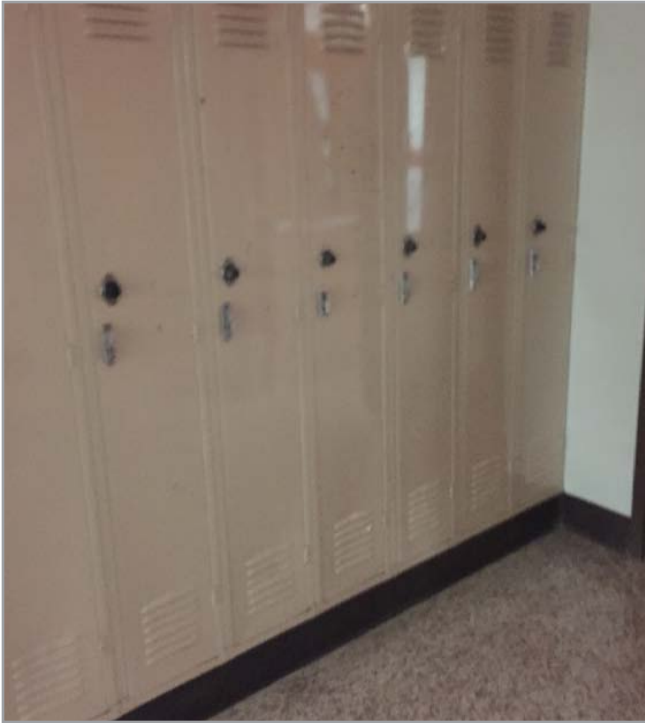
Damaged lockers in Corridor C162

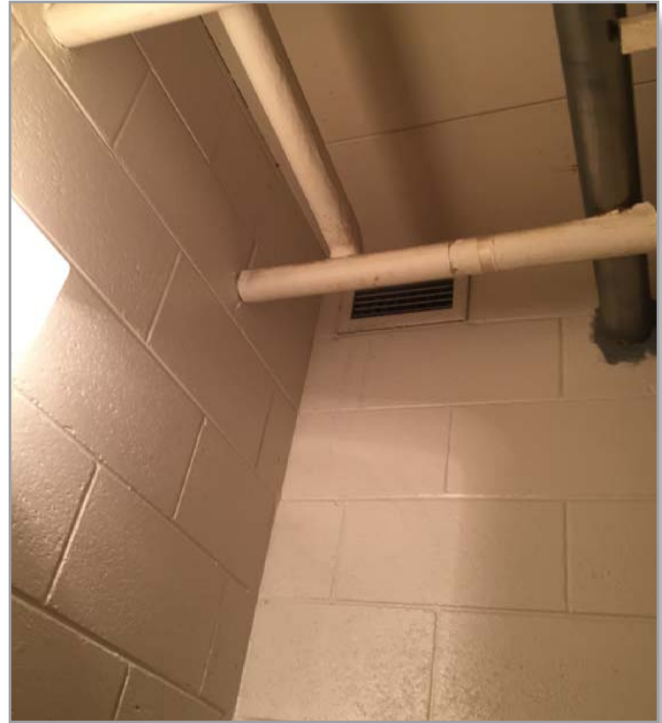
Add ceiling in Toilet Room C159

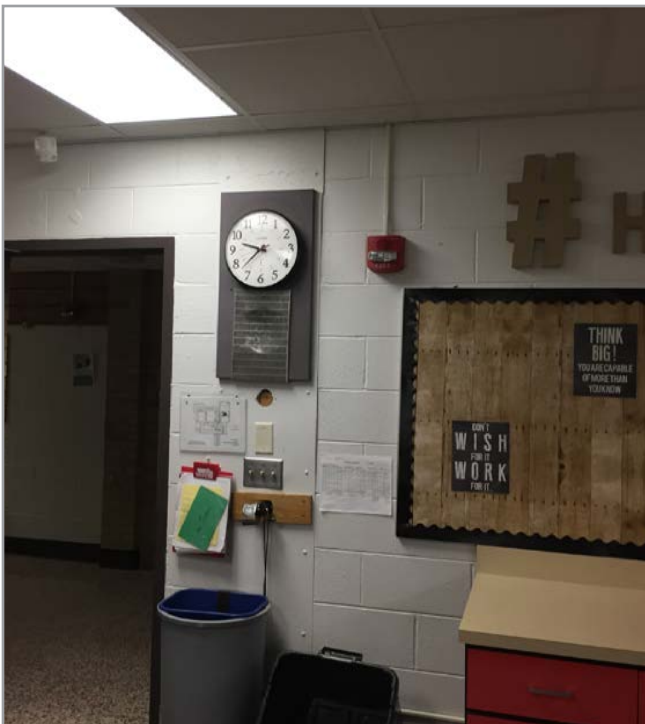
Upgrade clock and PA system

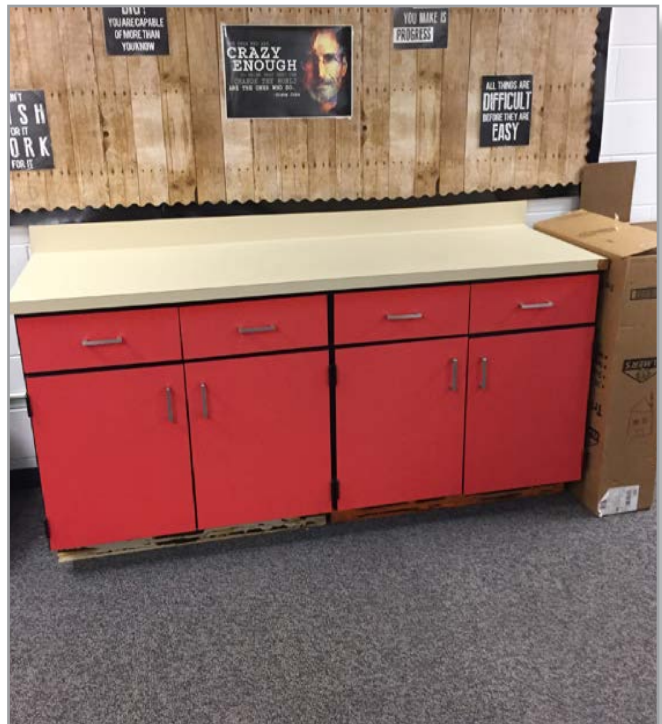
Upgrade typical classroom cabinets

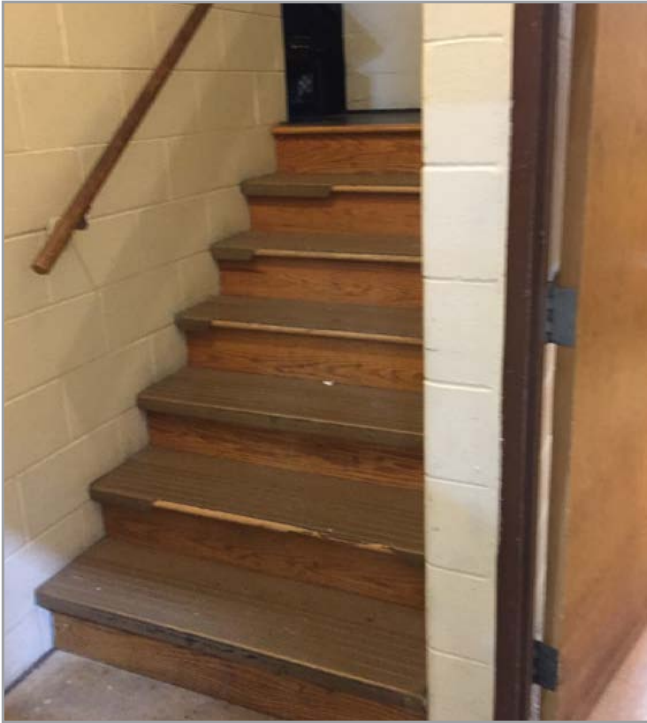
Provide Handicapped Accessibility to the Stage

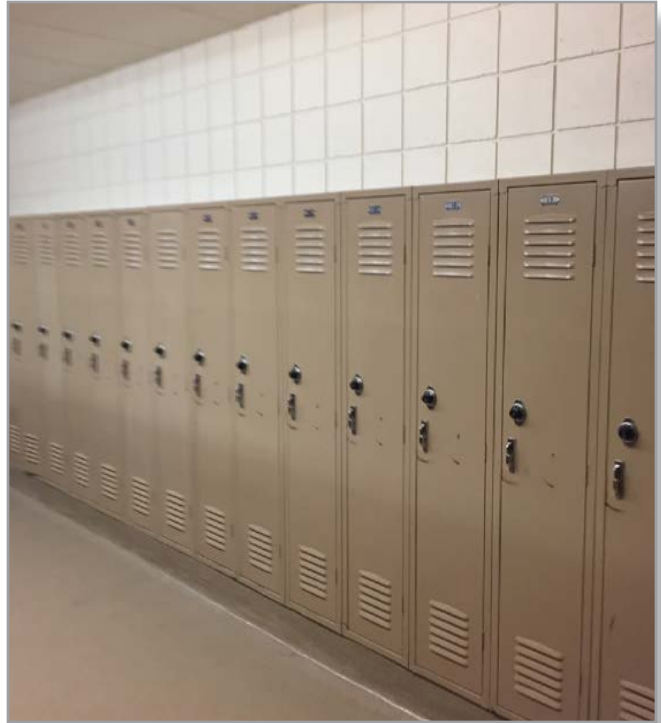
Replace the lockers in Girls JV Locker Room C111

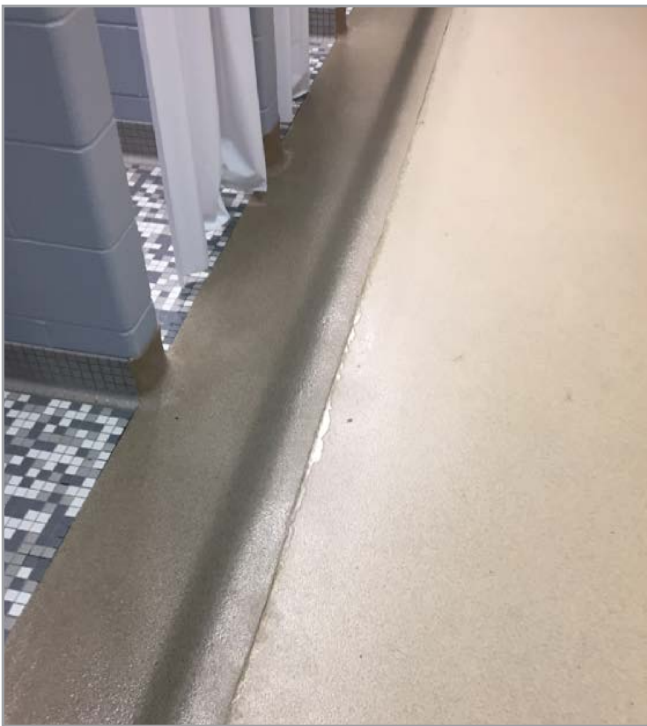
7.4.5.7 Varsity Boy's and Girl's Locker room flooring should be replaced with epoxy flooring. Budget includes approximately 1,952 square feet of epoxy flooring.

Replace epoxy floor in Girls Varsity Locker Room C140

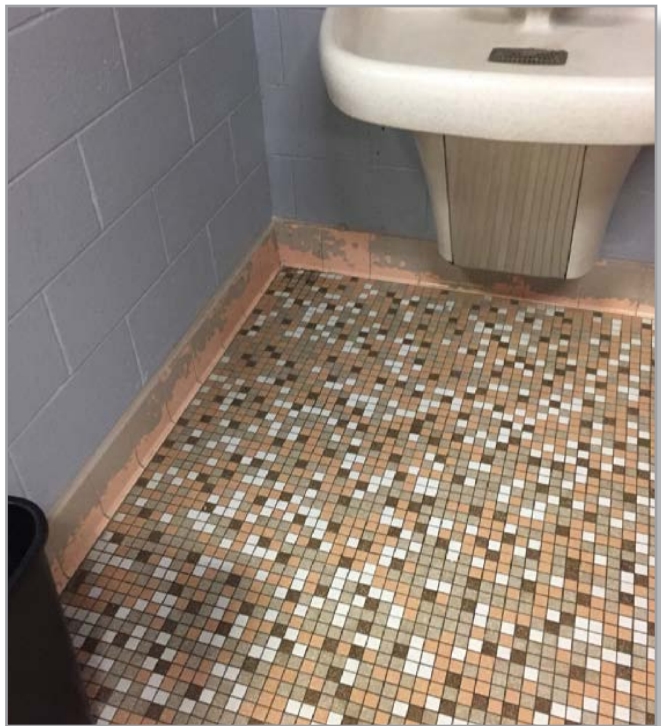
Upgrade finishes and accessibility in Toilet Rm C130

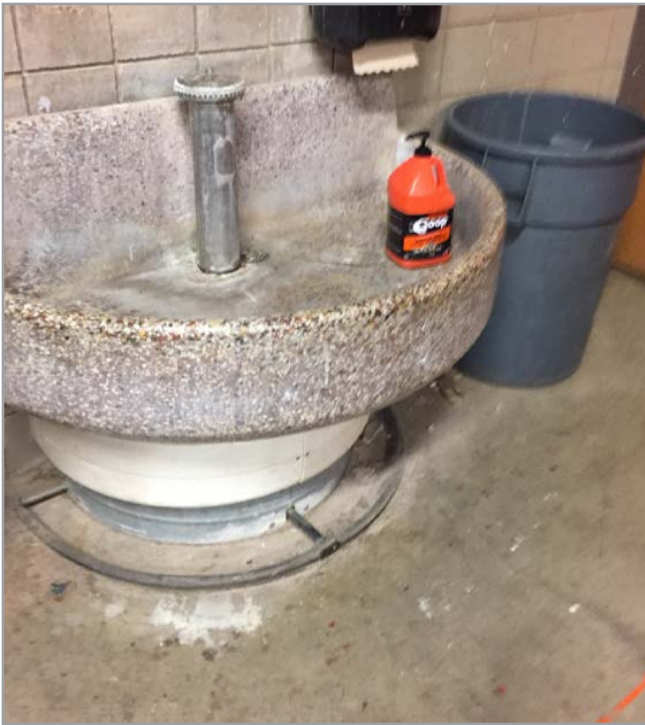
Replace wash fountain in Tech Ed C100

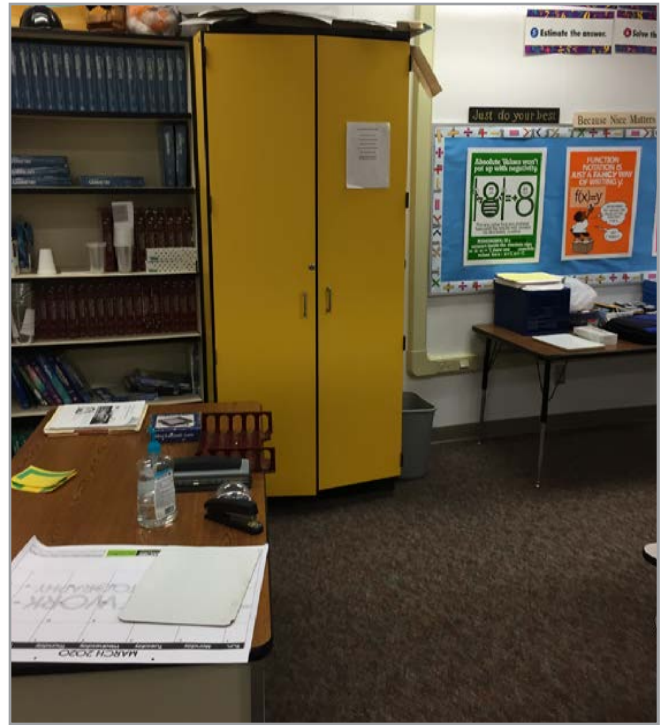
Replace storage cabinets in typical classroom

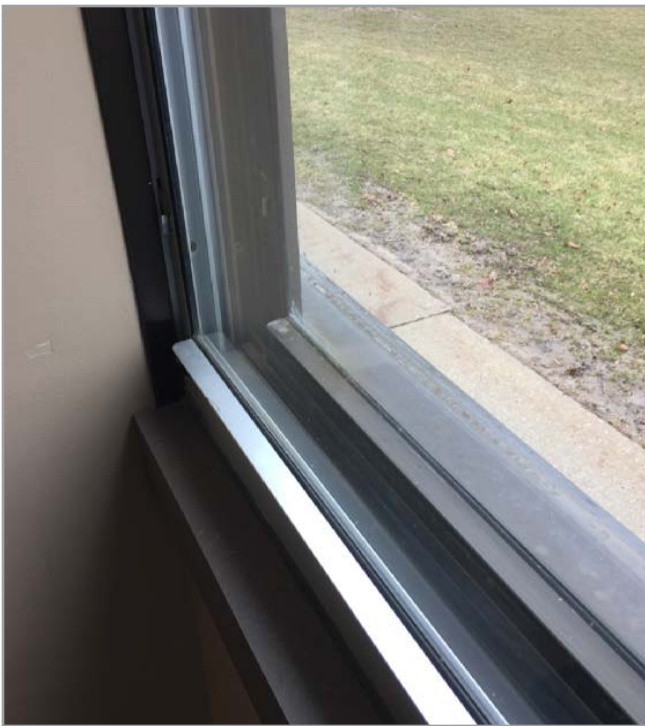
7.3.3.1 Some aluminum frame windows are in poor condition and should be replaced. Most show signs of water damage or thermal inefficiency. Window hardware and operators are non-functional or hard to operate. Budget includes replacing of approximately 12 existing windows. Replacement is assumed to be a one to one replacement with no impact to surrounding materials.

Replace double glass windows with insulated glass and aluminum frames

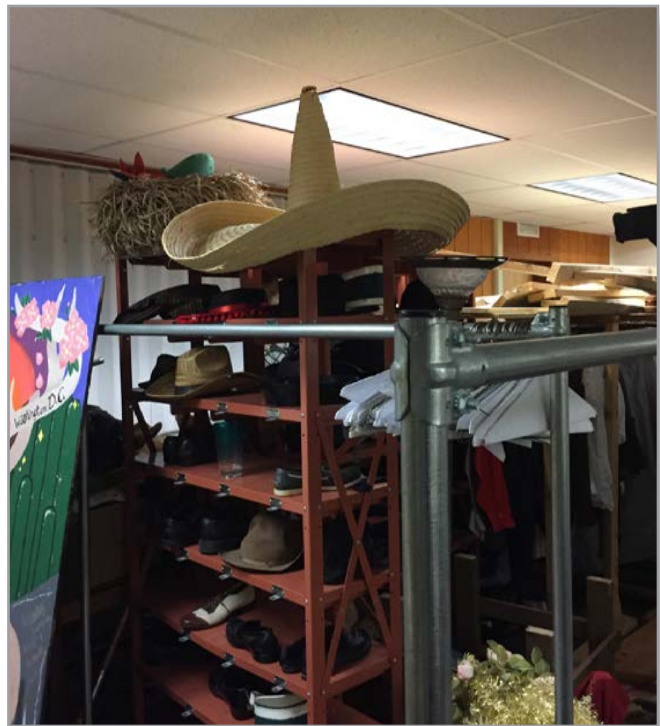
Move costume storage to new Buildings and Grounds addition

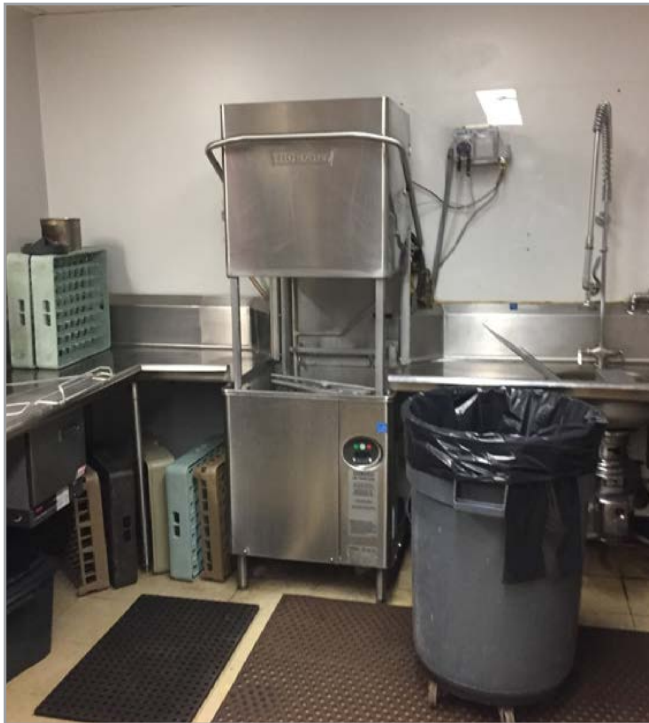
Move and enlarge existing Kitchen C157

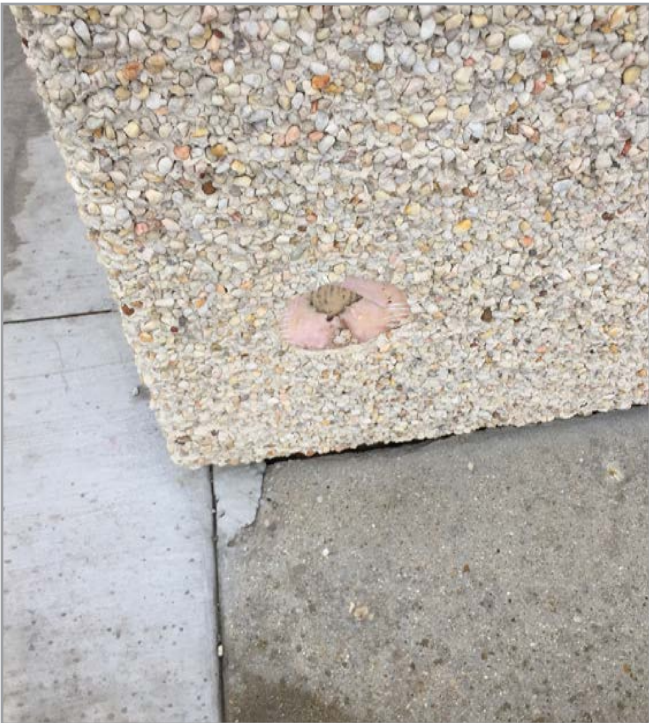
7.3.2.1 Several locations of damaged EIFS are damaged in need of repair. Large areas are soiled even after the EIFS was cleaned last year.

Damaged EIFS on exterior walls

7.3.2.2 All EIFS walls around the building are in poor condition and should be re-cladded with a siding material. Budget is based on covering or replacing the entire existing EIFS system for a total estimated square footage

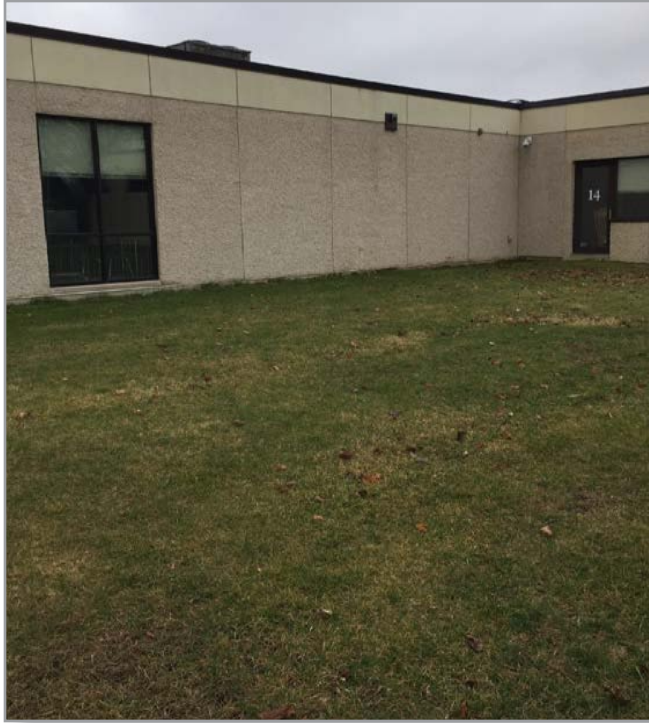
Soiled EIFS from roof

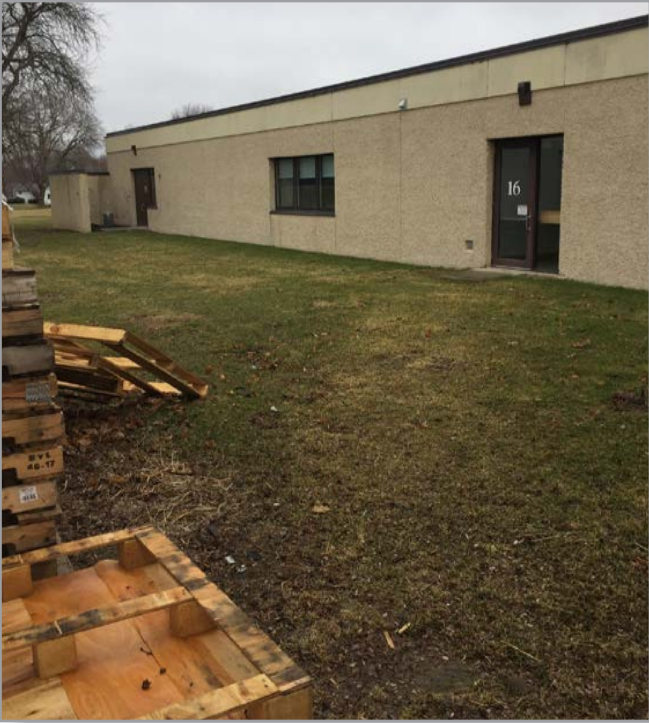
7.3.5.1 Some of the exterior doors around the building are in poor condition and should be replaced. Rusted holes and blistering paint are present at both the head and sills of the frame, while rusted edges are also present on the exterior doors. Budget for replacement includes special-lite FRP doors/frames for longer useful life. The estimated quantity of replacement is 17 locations.

Exit door and frame in need of replacing

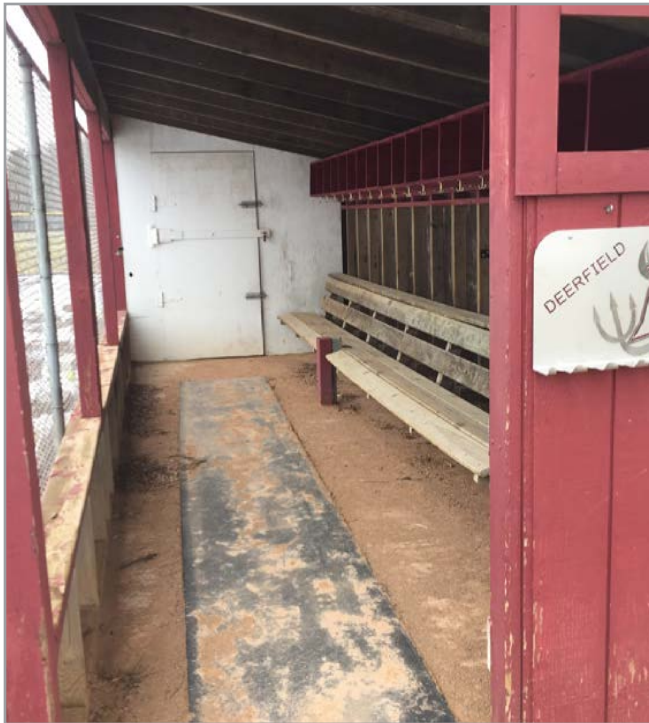
7.1.2.3 Replace softball diamond dugouts to match the baseball dugouts.

Replace existing Softball dugouts

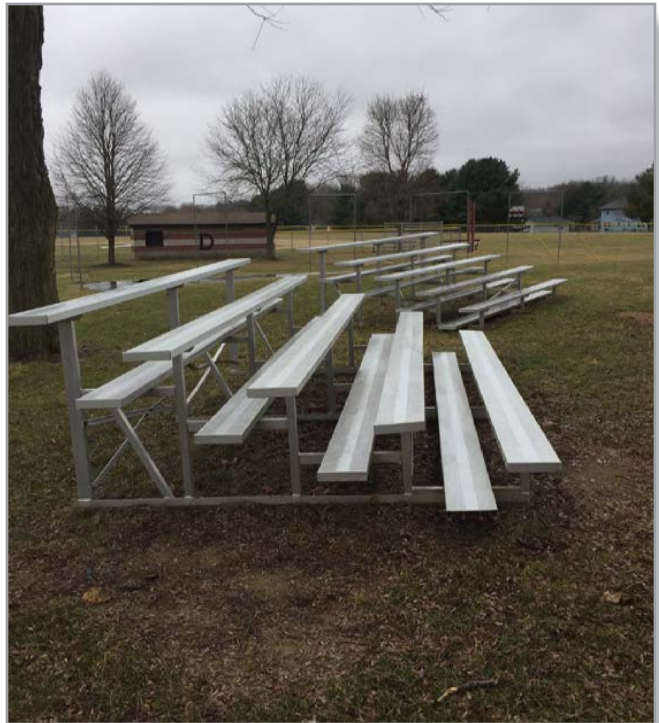
Replace unsafe Baseball and Softball diamond bleachers
