CAPITAL FACILITIES ASSESSMENT JULY, 2020

# DEERFIELD COMMUNITY SCHOOL DISTRICT

This evaluation is intended to survey the physical condition of the buildings located within the Deerfield Community School District and to develop a Capital Facilities Assessment. These buildings include Deerfield Elementary, District Offices and Deerfield Middle School / High School. This report analyzes the appearance and condition of the Architectural, Plumbing, HVAC, and Electrical systems of the buildings. This data is used to determine the feasibility and cost of implementing maintenance solutions to preserve the integrity of the buildings.

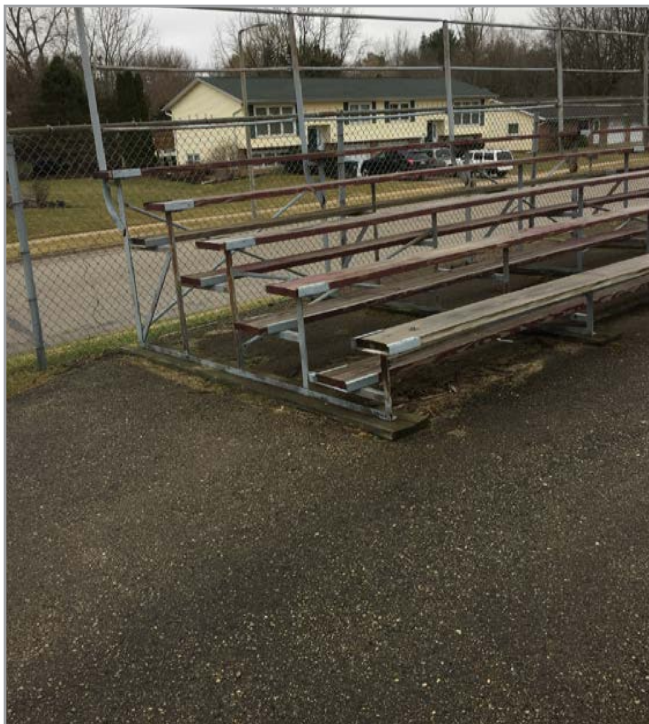
7.1.2.2 The visitor bleachers need to be replaced. Budget includes providing new bleachers with capacity of 250 and 8 inch rise.

Replace unsafe visitor football bleachers

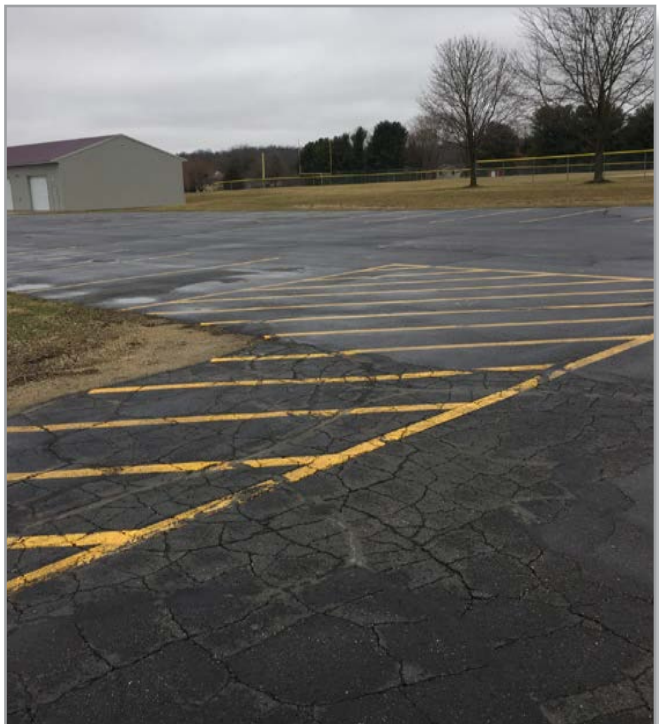
7.1.1.2 The asphalt is in poor condition except for an area on the east side that was repaved two years ago. Budget includes removal, resurfacing asphalt striping.

Replace damaged and worn asphalt
